NACA RM E9K17

TURBOJET-ENGINE EVALUATION OF AISI 321 AND AISI 347

STAINLESS STEELS AS NOZZLE-BLADE MATERIALS

By Floyd B. Garrett and Charles Yaker

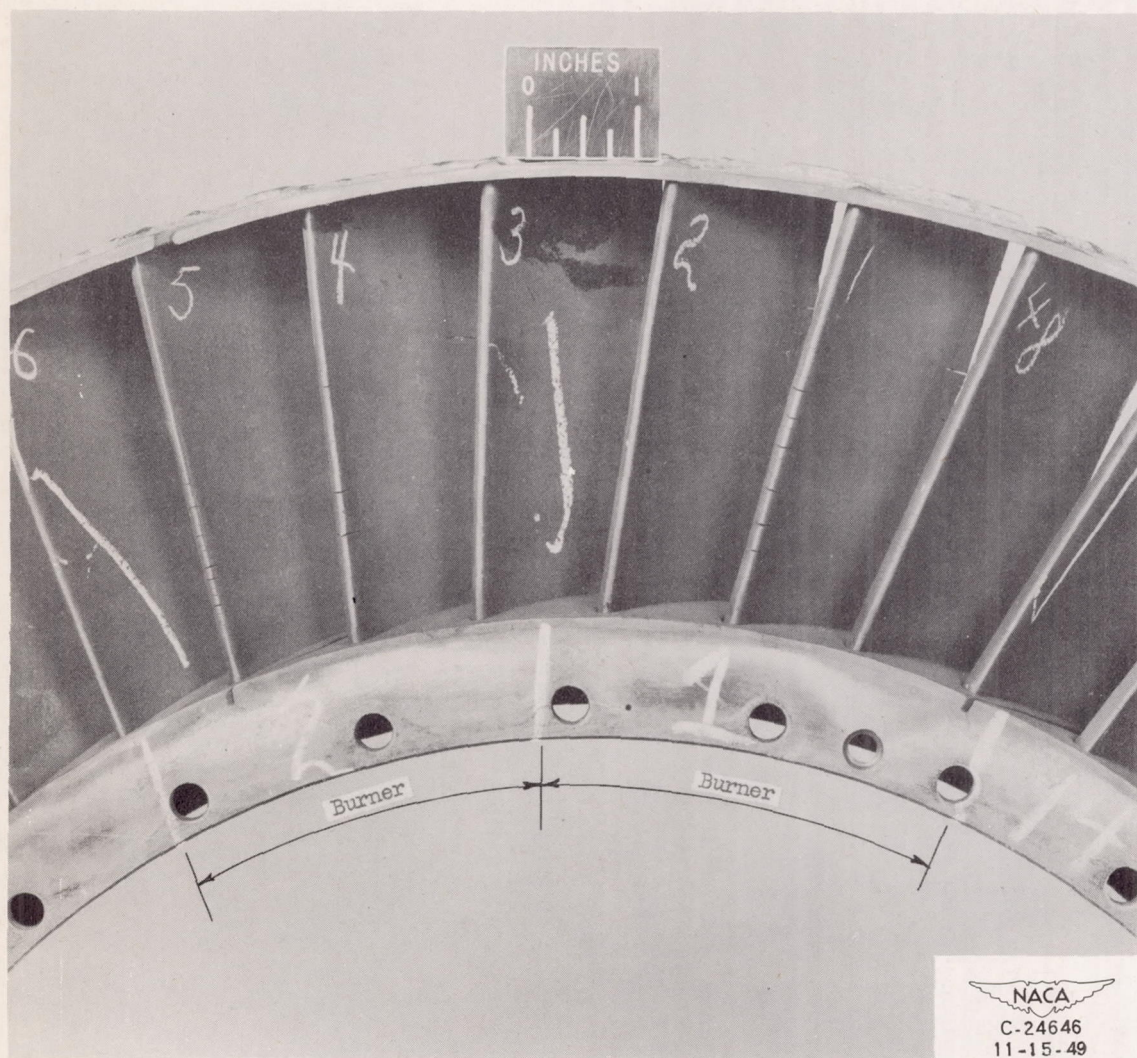
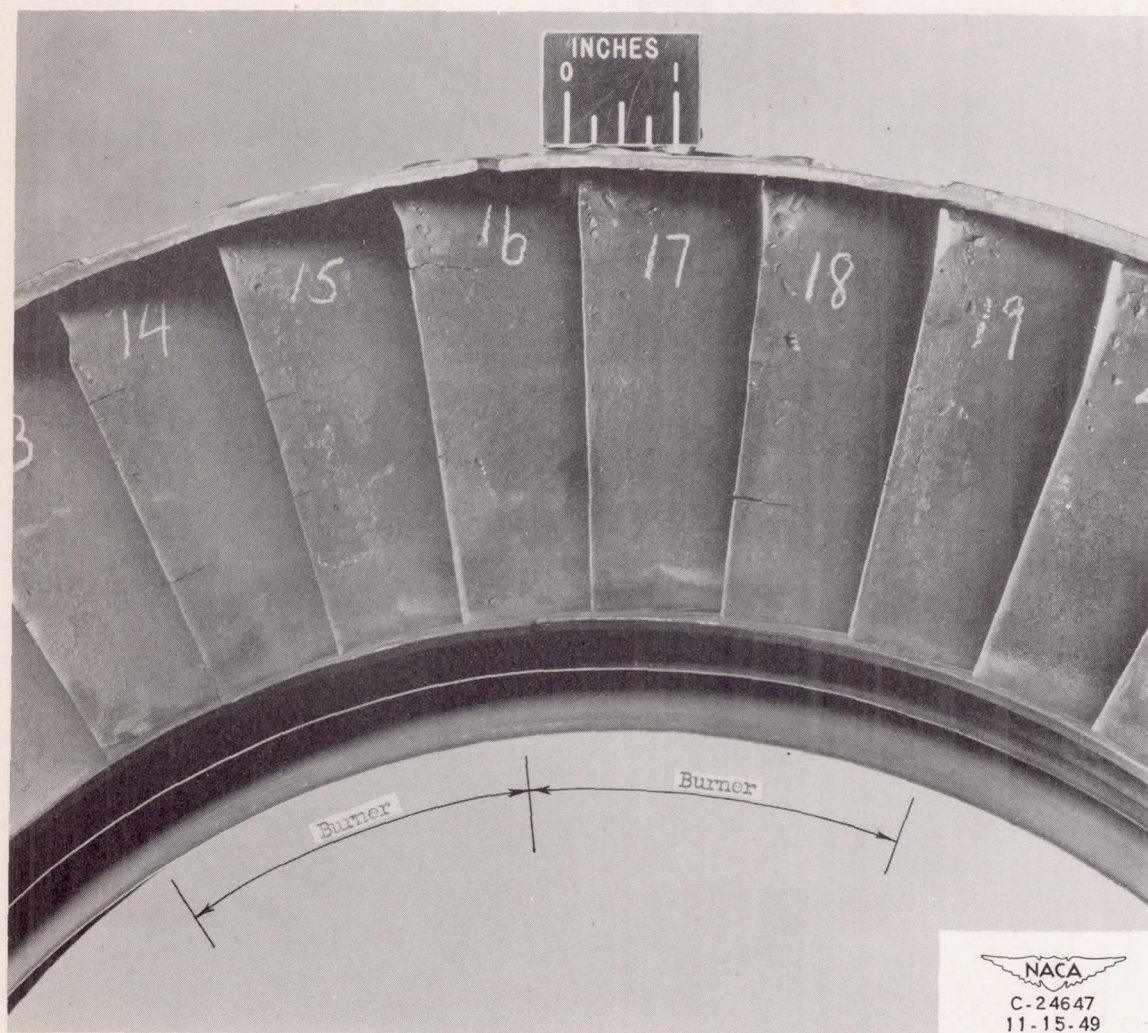
Examination of the nozzle diaphragms after operation revealed that a definite relation exists between burner location and blade cracks. Typical examples of the condition of the diaphragm blades after 319 cycles (106 hr, 20 min) of operation are shown in figure 2. These photographs clearly indicate that the severely cracked blades are generally located opposite the center of the burner outlet. Slight differences were noted between blades opposite various burners, which can be attributed to differences in combustion characteristics of the burners.

Figure 2. - Portion of nozzle diaphragm 3 after 319 cycles (106 hr, 20 min) showing blade condition with respect to burner locations.

Figure 2. - Concluded. Portion of nozzle diaphragm 3 after 319 cycles (106 hr, 20 min) showing blade condition with respect to burner locations.

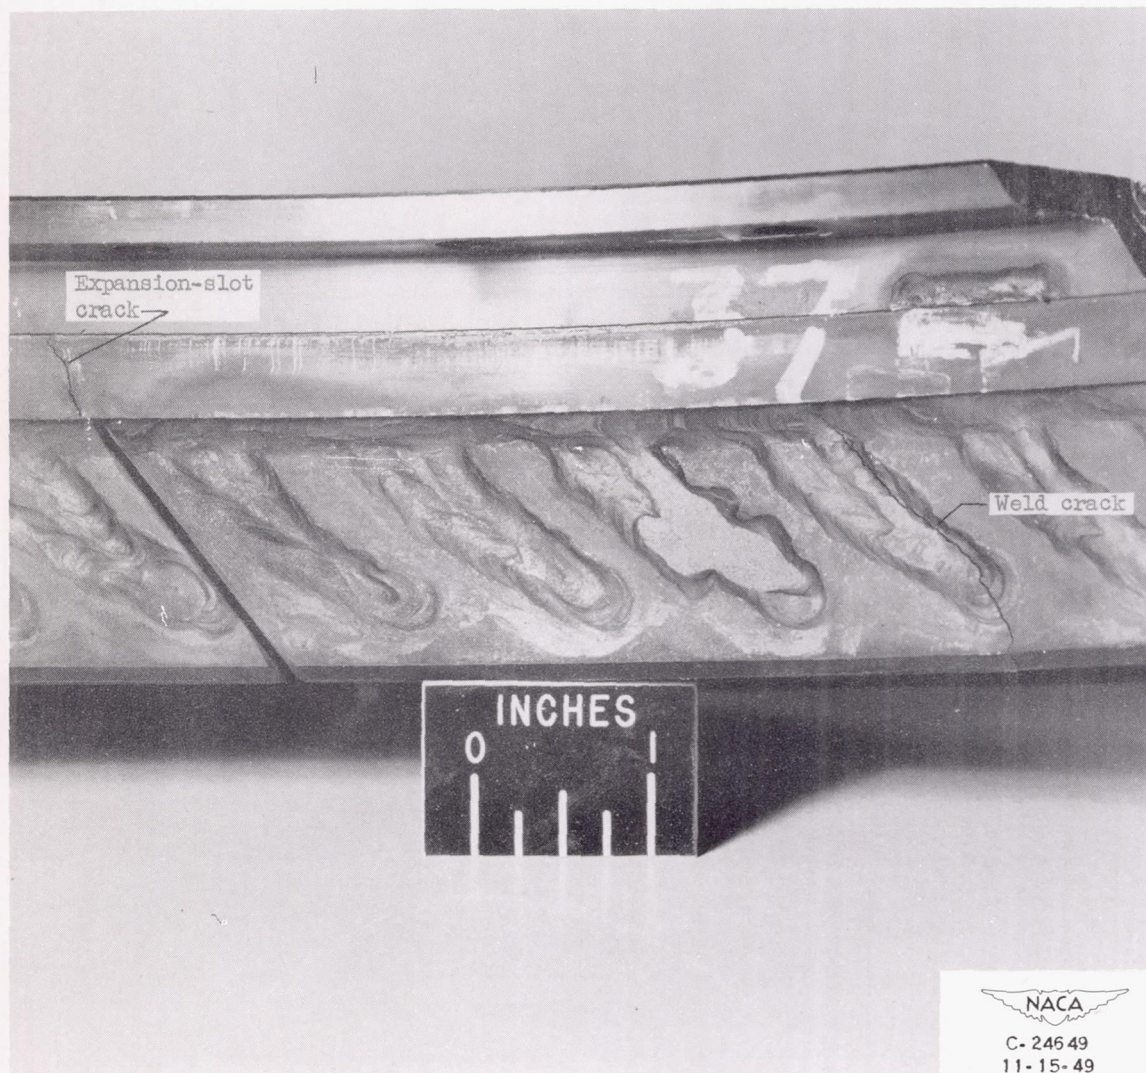
One of the more severe weld cracks is shown in figure 4. The location of the crack is typical of both types of weld. Shown also is a crack in the spacer ring at the end of the expansion slot. Cracks of this type were found at the end of all the expansion slots in the inner-spacer ring of nozzle diaphragm 3. Similar cracks were present in nozzle diaphragm 1 but not in nozzle diaphragm 2.

Failure of welds and inner-spacer ring. - The weld and inner-spacer-ring-slot cracks were probably caused by stresses resulting from unequal thermal expansion between blades due to differences in temperature between burner centers and edges and also differences in temperature from burner to burner. These conditions can possibly be eliminated by changes in design.

Figure 4. - Typical inner-spacer ring and weld cracks in nozzle diaphragm 3 after 319 cycles (106 hr, 20 min) of operation.

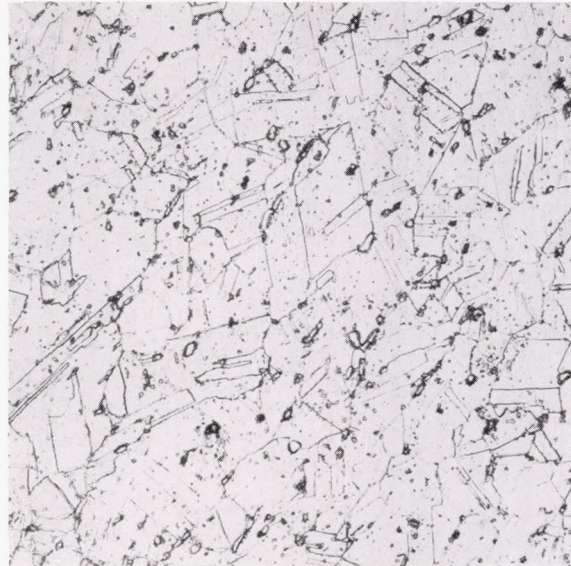
(a) AISI 321 stainless steel (titanium modified).

The structures of the two types of alloy before operation are shown in figure 5. Each structure consisted of small equiaxed grains of austenite containing small patches of complex carbides. Typical leading-edge cracks in the two alloys after 319 cycles (106 hr, 20 min) are shown in figure 6. This figure indicates that some intergranular penetration and precipitation have occurred at the leading edge of the AISI 347 blade. The AISI 321 blade shows no appreciable intergranular penetration. Each of the cracks shown is about 1/32 inch long. In the case of both blades, there were much longer cracks; and in the case of AISI 347 blades, the cracks

Figure 5. - Microstructure of nozzle blades before operation. X250.

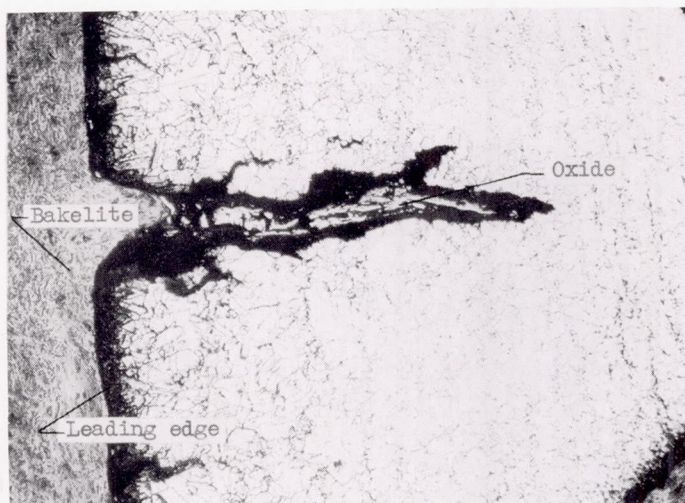
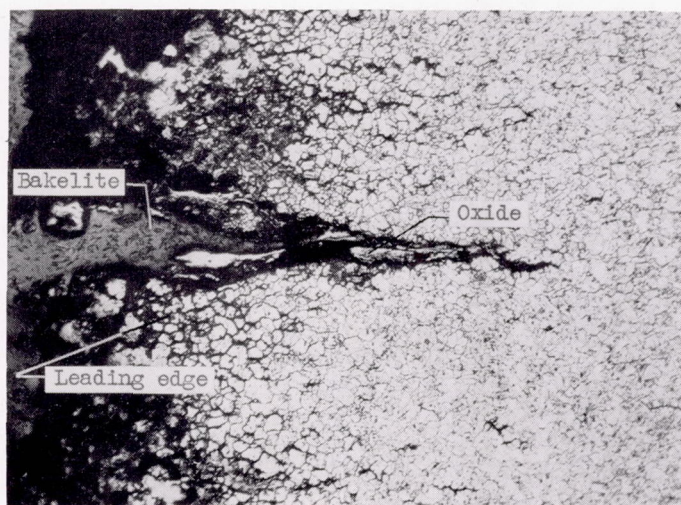
Leading edge. - Microexamination indicated that the leading-edge cracks of the two alloys (fig. 6) were different in nature. The AISI 347 blade cracks were similar to an intergranular creep type of failure and the AISI 321 blade cracks similar to corrosion-fatigue failure. The AISI 321 blades also revealed some intergranular cracks (fig. 9). In both cases, however, the number of cracks and their respective depths were of the same magnitude. The exact mechanism of cracking cannot be determined, but these failures can be regarded as resulting from the combined effects of constant thermal stress, alternating sudden thermal stress, and the oxidizing atmosphere.

Figure 6. - Typical leading-edge cracks after 319 cycles (106 hr, 20 min) of operation.  
X100.

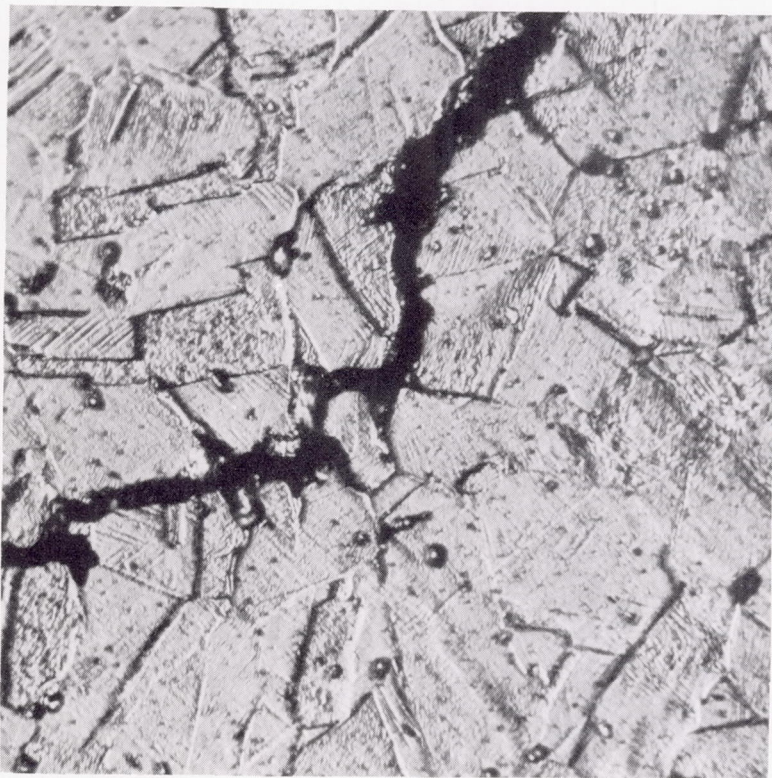
Examination of the cracked AISI 347 blade in nozzle diaphragm 2 indicated that the cracks in both the leading and trailing edges were intergranular. These cracks contained little or no oxide, inasmuch as they occurred between 70 (23 hr, 20 min) and 80 cycles (26 hr, 46 min) of operation with no further operation. The intergranular penetration at the tip of a crack, which is typical of cracks in both edges, is shown in figure 8. Two types of penetration beginning at the leading edge of a blade are indicated in figure 9. One type is intergranular penetration, and the other is surface pitting.

Figure 8. - Intergranular crack propagation in AISI 347 stainless steel after 80 cycles (26 hr, 40 min) of operation. Oblique illumination; X1000.

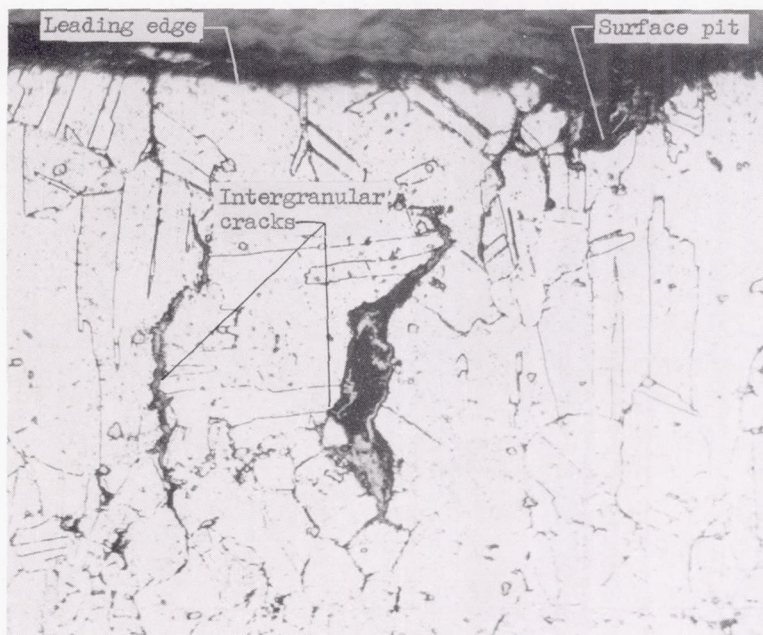
Figure 9. - Initial crack penetration in AISI 321 stainless steel after 319 cycles (106 hr, 20 min) of operation. X500.
